Cross Fox Condominium, Inc.

Columbia, Maryland

ALUMINUM WIRING IS REQUIRED TO BE REPAIRED BY 2021

ALUMINUM WIRING UPGRADE REQUIRED IN 2021

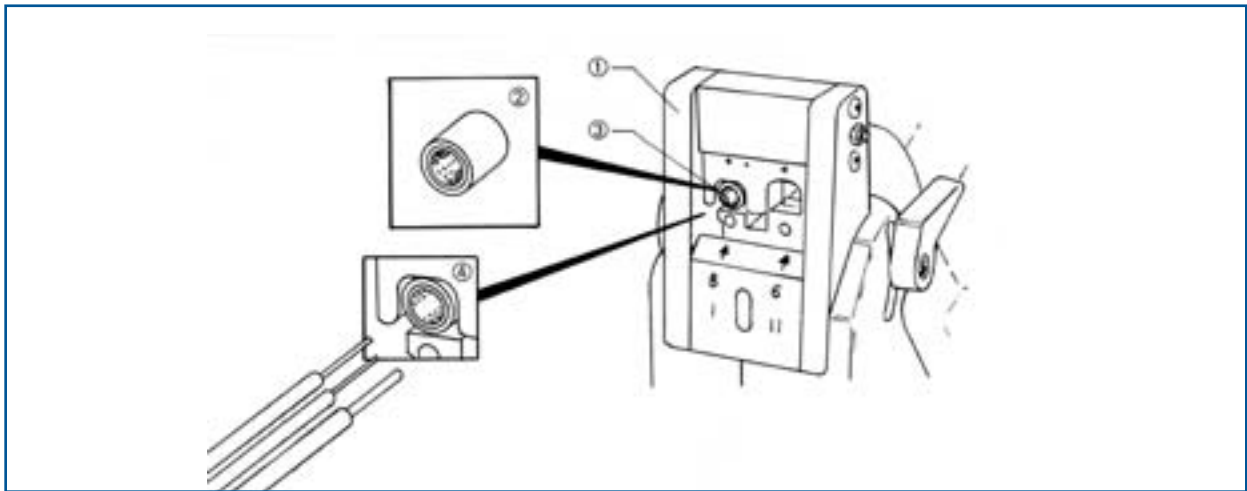
COPALUM Crimp Connector and its Specialized Installation Tooling

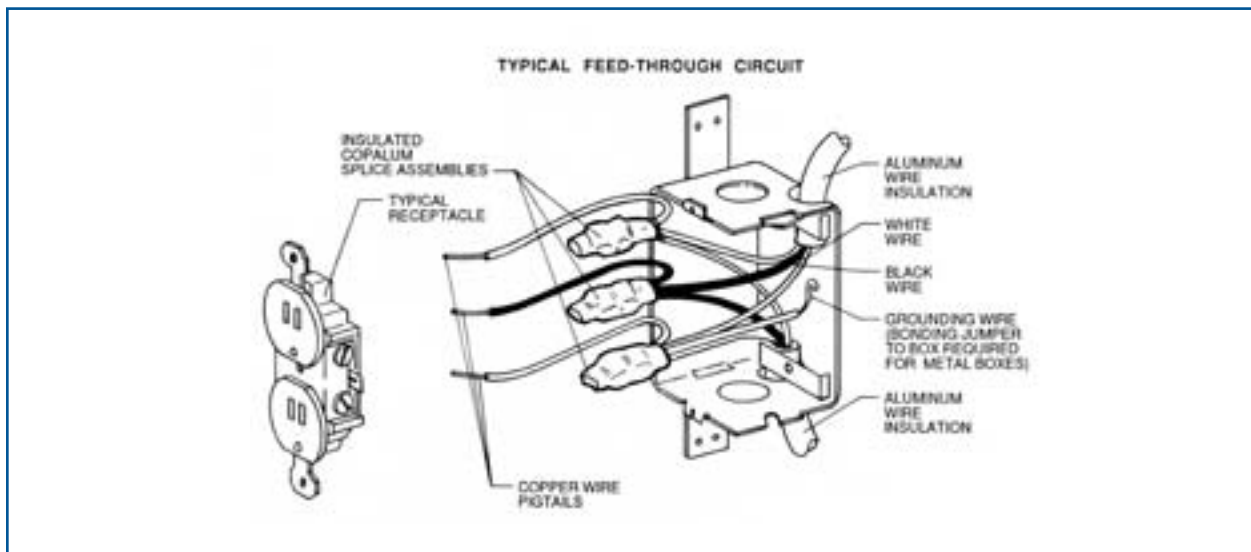
Recommended COPALUM Connector Repair

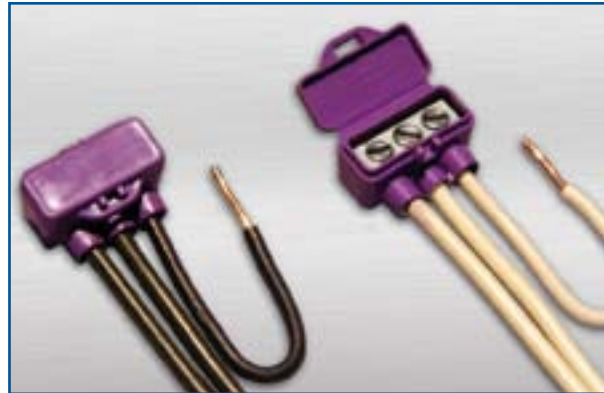
The AlumiConn Connector

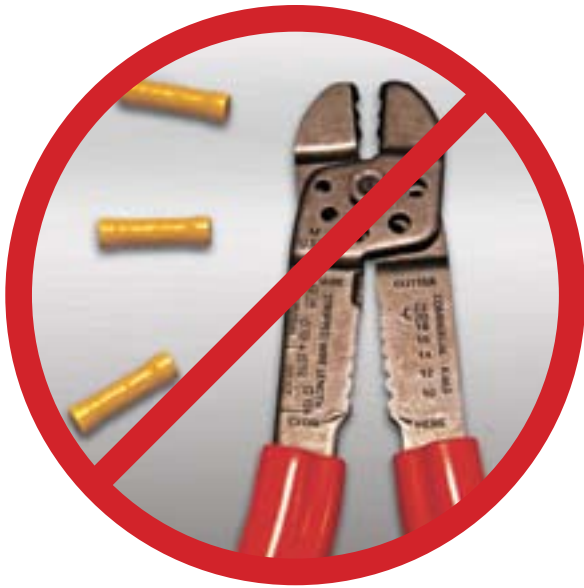
No other crimp connectors have been evaluated for connecting copper and aluminum conductors. CPSC staff strongly recommends against their use as a repair method.

Do Not Use Common Hand-Crimped Connectors with Aluminum Wire

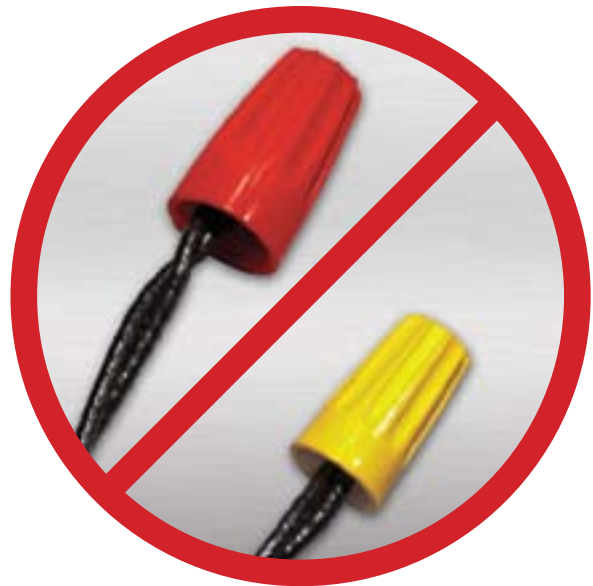
The first temporary repair involves pigtail with a twist-on connector. The effectiveness of “pigtail” using twist-on connectors has been evaluated by CPSC staff. In CPSC-sponsored laboratory testing and life tests, substantial numbers of these connectors overheated severely.

“Pigtail” with Twist-on Connectors Is Not a Recommended Repair
