Cross Fox Condominium, Inc.

Columbia, Maryland

ALUMINUM WIRING IS REQUIRED TO BE REPAIRED BY 2021

ALUMINUM WIRING UPGRADE REQUIRED IN 2021

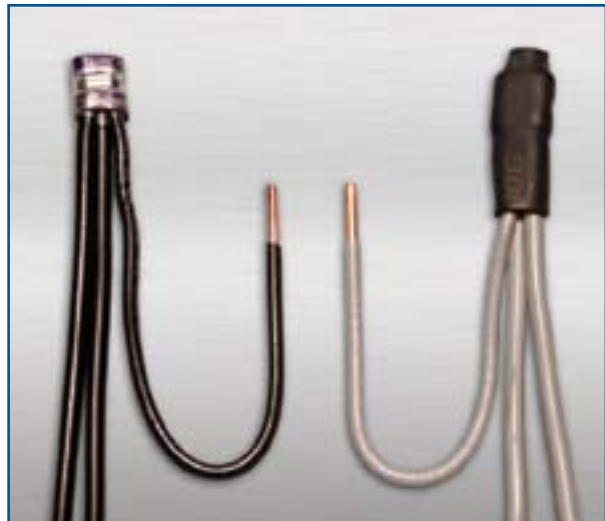
The COPALUM connector is a specially designed system that includes a metal sleeve intended to be installed only with a dedicated power tool and crimping die to make a permanent connection, that is, in effect, a cold weld (the precision dies in the COPALUM tool compress the connector and wires using upwards of 10,000 pounds of force, as required to make the permanent aluminum wire connection).

The tool is shown in the illustration below. An insulating sleeve is placed around the crimp connector to complete the repair. The copper wire pigtail is then connected to the switch, receptacle, or other termination device. An example of a repaired receptacle outlet is also illustrated below.

Only electricians who are trained by the manufacturer to use the tool properly are authorized to install COPALUM connectors. CPSC staff emphasizes that this training is necessary to ensure that the electrician uses the careful, professional workmanship and thoroughness required to make the crimp connector repair safe and permanent.
